LuK Service Info

Concentric Slave Cylinder 510 0180 10

Dirt particles in the hydraulic fluid can cause failure

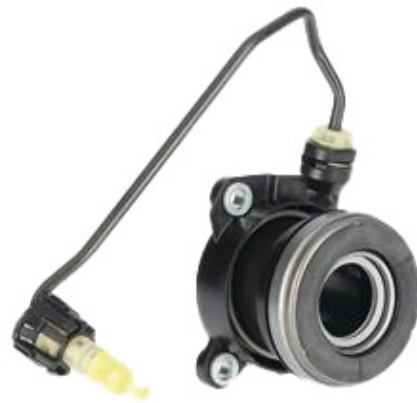
Figure 1: Concentric slave cylinder 510 0180 10

After the concentric slave cylinder has been replaced, the clutch hydraulics must be bled. In individual cases, depending on the maintenance status of the hydraulic fluid, dirt particles may impair the function of the bleeding adapter. These clog the bores of the inner aperture, which creates a kind of valve action. This will allow the hydraulic fluid to flow only in the direction of the concentric slave cylinder and no longer, or only partially, flow back. Just after a few actuations of the clutch, this causes the concentric slave cylinder to burst.

To fully exclude this source of error, it is recommended that you also replace the bleeding adapter when replacing the concentric slave cylinder.
